# IMPROVING THE 10" HEAD ALLIANCE COUPLER AND KNUCKLE

## SUMMARY

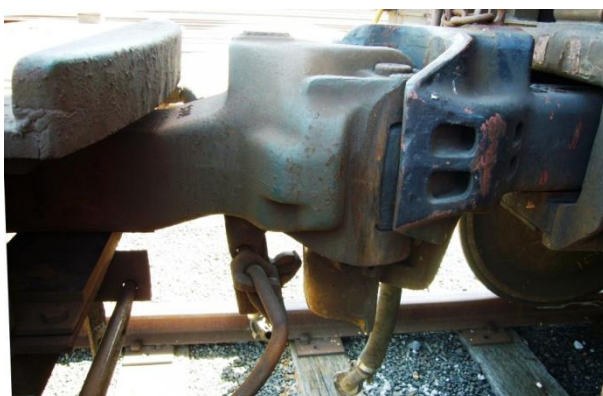
Figure 1 : Upset & Straight Alliance Couplers

Originally produced in Alliance, Ohio, from which it derives its name, the standard Alliance coupler was developed concurrently to the Type D coupler by ASF. It was designed to be a lower weight and used a 10" head length which was shorter than the 12" head length of their Type D counterpart.

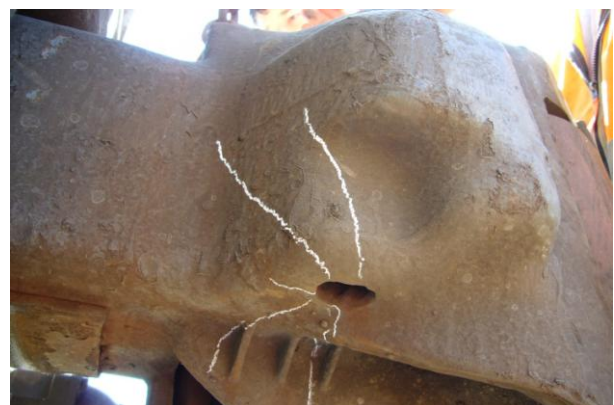
Figure 2 : Hole in Bottom Pulling Lug Floor

1. Bottom pulling lug including hole in floor;
2. Excessive wear and deformation of coupler pin supports;
3. Cracking between lower scallop of coupler throat opening and guard arm;
4. Longitudinal upper web / tie bar behind push face;
5. Cracking through internal parting line of coupler head where locking block is fitted;

In contrast, special attention was focused on the lower pulling lug region where the pulling lug was able to be blended more gradually into the floor region, and the floor thickness increased. Additionally, the need for a hole in the lower pulling lug floor was removed which eliminated this crack initiation site. Similarly, there was a special focus on reducing the stresses in the upper pulling lug and the upper longitudinal rib (tie bar member). This was achieved by reducing the overhang of the pulling lug, increasing the width of the longitudinal rib and blending it more gradually between the front buff face and the rear of the coupler head.

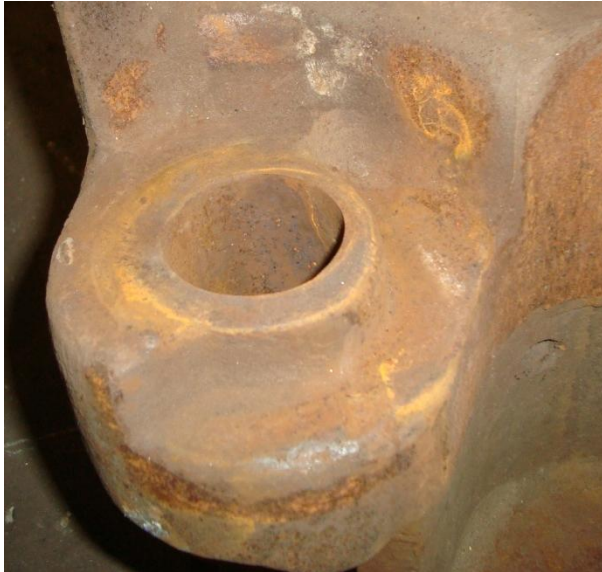
**Figure 3 : Deformation of Coupler Pin Support**

Further, in draft both upper and lower coupler / knuckle pin supports, in addition to the locking block, act as reaction faces to resist the rotation of the knuckle within the coupler head when in the locked position. These pin supports also partially transfer the draft load. These pin supports are subjected to high loads resulting in excessive wear and plastic deformation as can be seen in the FEA results and couplers in service. While wear is expected to normally occur at these pin supports and at the pulling lugs, it is desirable to reduce the amount of yielding as it can result in a redistribution of reaction forces in the coupler / knuckle resulting in forces in regions that differ significantly from design.

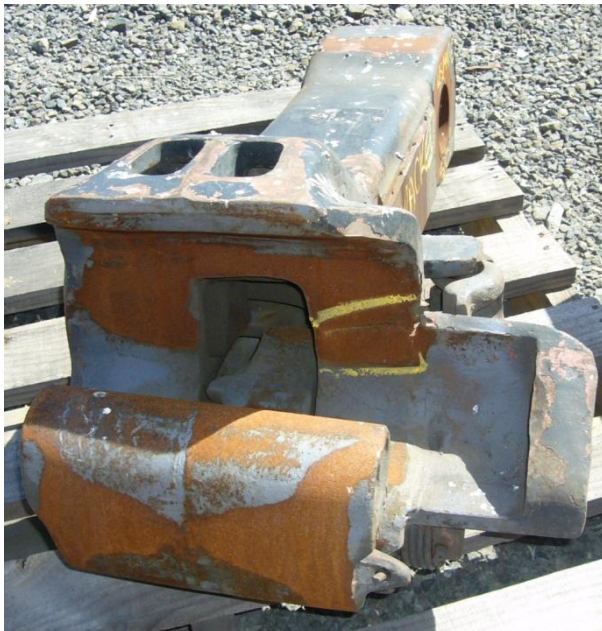
**Figure 4 : Cracking between Throat and Guard**

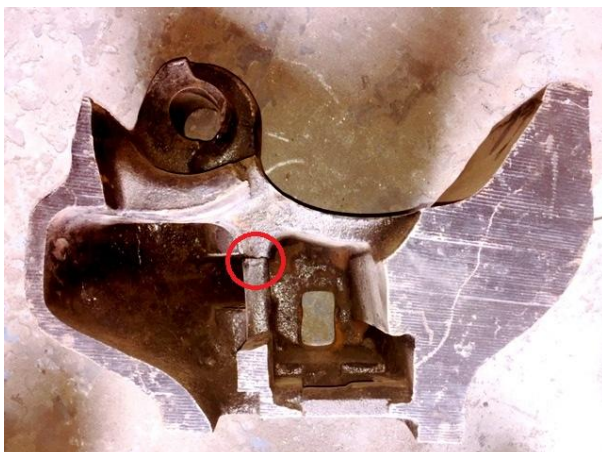
**Figure 5 : Cracking through Longitudinal Web**

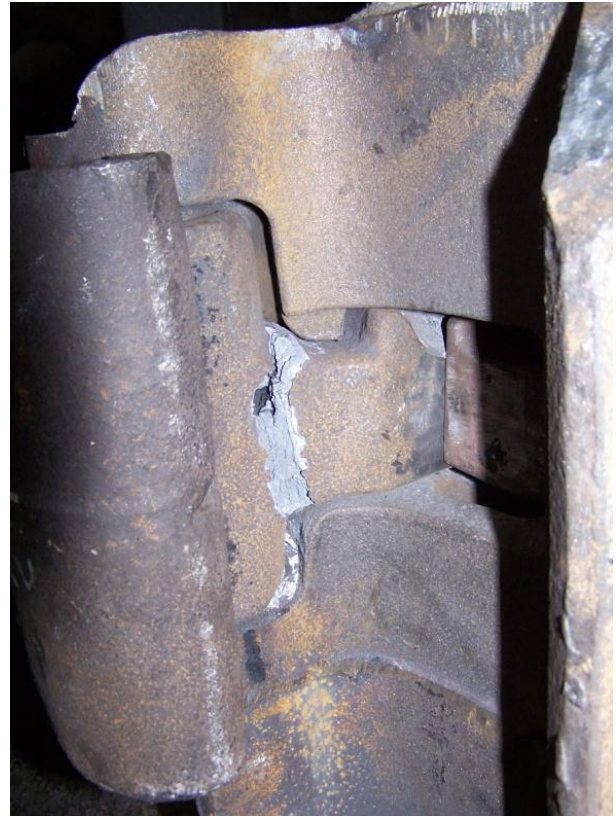
**Figure 6 : Knuckle Failure through Neck**

1. Neck region of the knuckle, which is the thin region between the pulling lugs and the knuckle shoulders. An example of failure in this region is seen in Figure 6.
2. Knuckle Pin Hole. An example of failure in this region is seen in Figure 7.

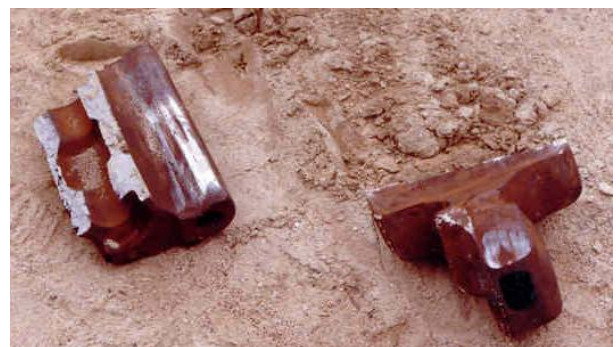
**Figure 7 : Knuckle Failure through Pin Hole**

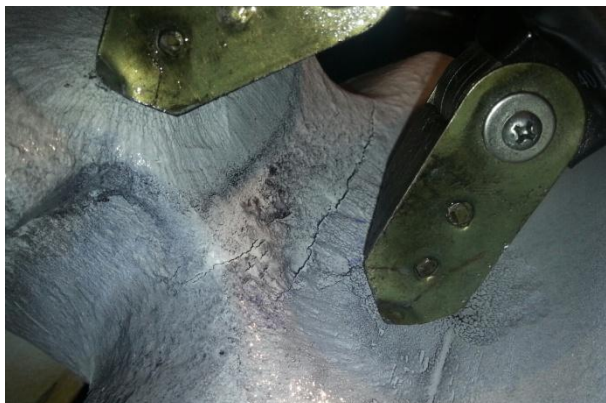
**Figure 8 : MPI Showing Fatigue Cracks**

manufacturer, the primary location for cracking occurred through the neck region. Fatigue cracking in this region can be seen in Figure 8 and is a known failure area. Metallographic examination revealed that fatigue cracking was often associated with weld repairs or casting defects in this region.

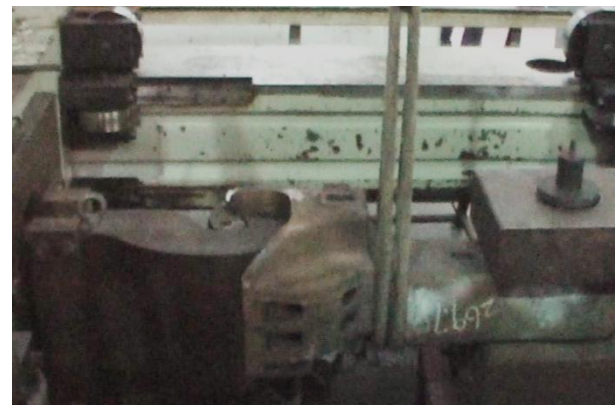
**Figure 12 : Physical Static Testing**

To ensure the validity of the FEA results, physical static strength tests were performed as per AAR M-211. The Alliance knuckle and coupler were connected to the test rig with a dummy knuckle fixture used to load the coupler assembly as shown in Figure 12. A comparison between the FEA and physical test results can be seen in Table 3.

As can be seen in Table 3, the static strength FEA and physical test results were very close in values, with only an approximate 15% variance. This slight difference in values was most likely to be accounted for by a variation in material properties between the minimum AAR Grade E yield and tensile strength values used in the FEA and the slightly higher material strength values that occur in actual production. Thus the results of physical testing only further validated the FEA stress analysis and confirmed that the restraints and loading conditions used were appropriate.
